FULL RESERVE STUDY

Steeplechase Subdivision

Homeowners Association, Inc.

April 5, 2019

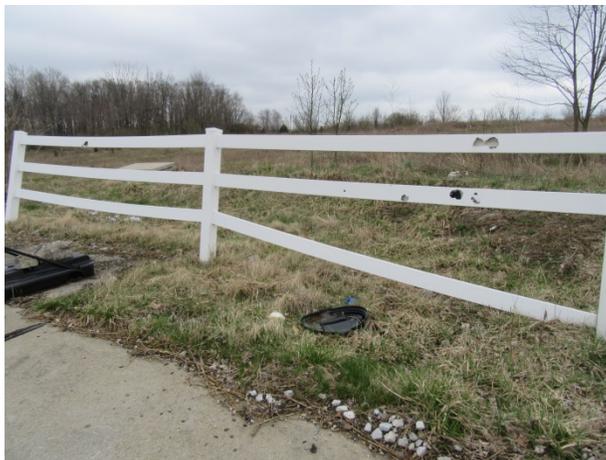
Fence damage

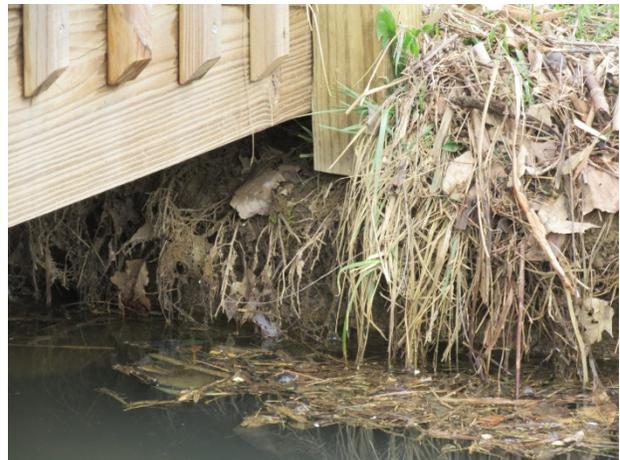
Support on eroding shoreline

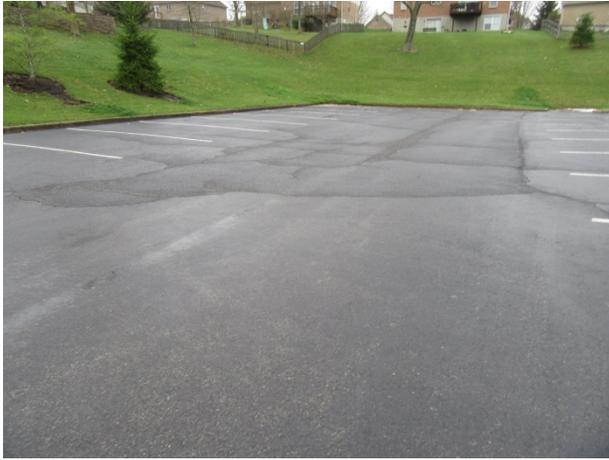
Condition: Fair overall with isolated tire ruts, water accumulation and systematic cracks evident

Pavement cracks

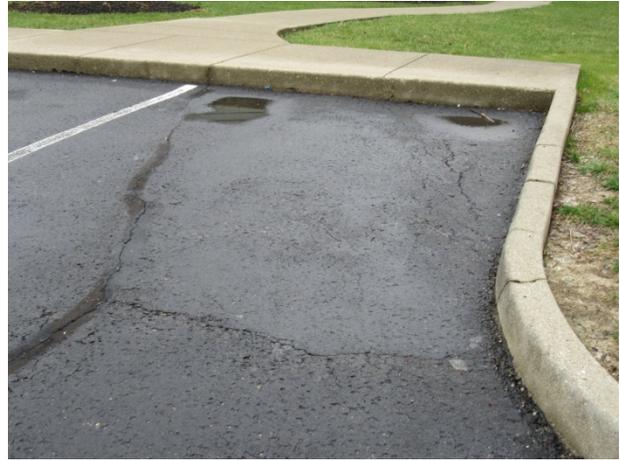
Tire ruts and cracks

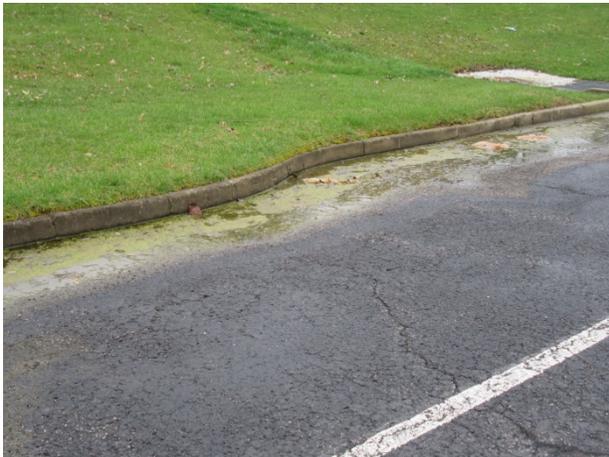
Water accumulation

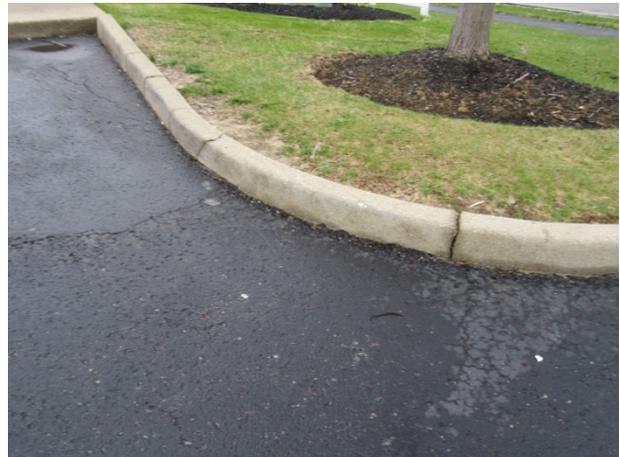
Curb cracks

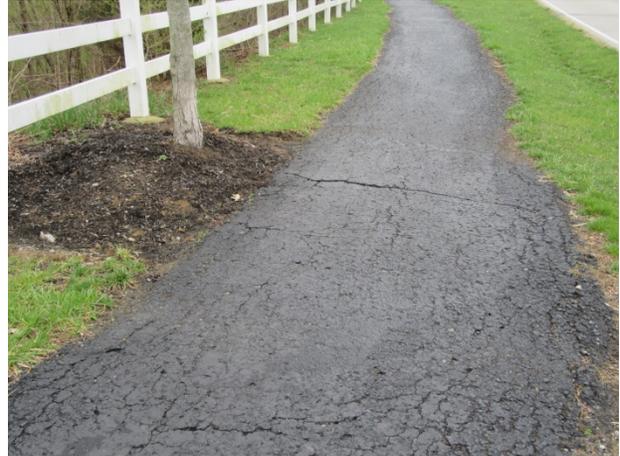
Crack likely due to tree root near clubhouse

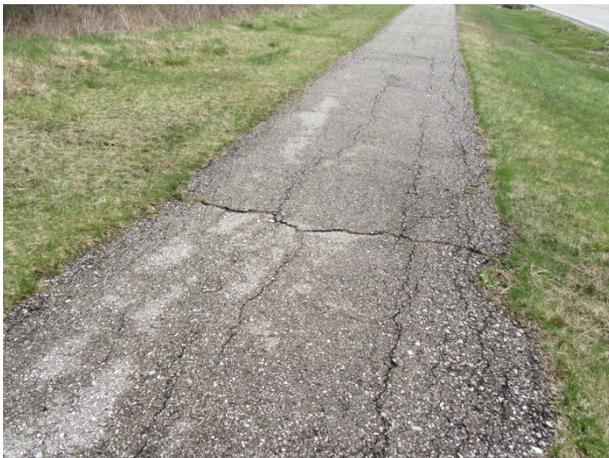
Cracks near Turfrider Court

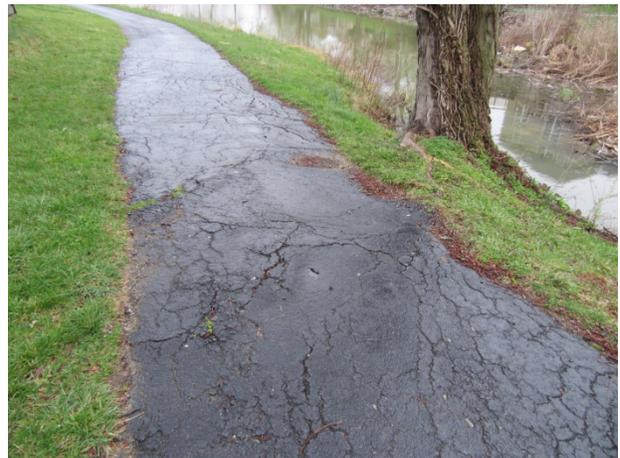
Alligator cracks and upheaval due to tree roots near northern bridge

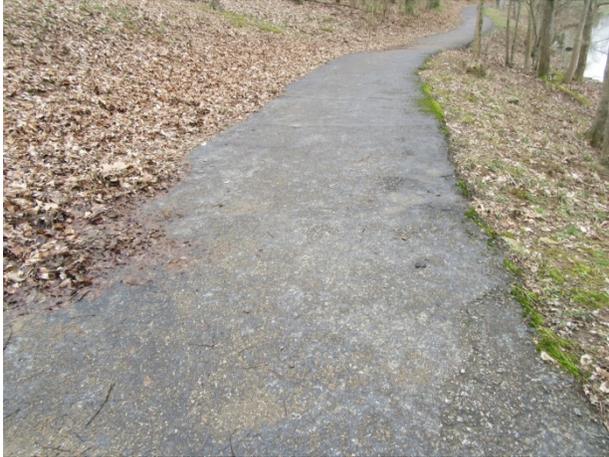
Uneven surface southeast of central pond

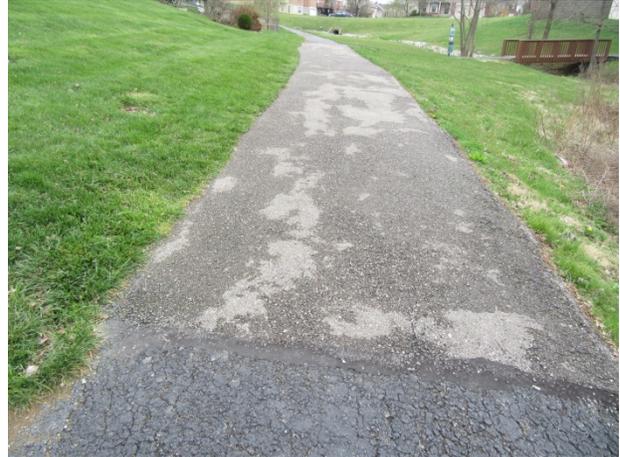
Partial replacement near northern bridge

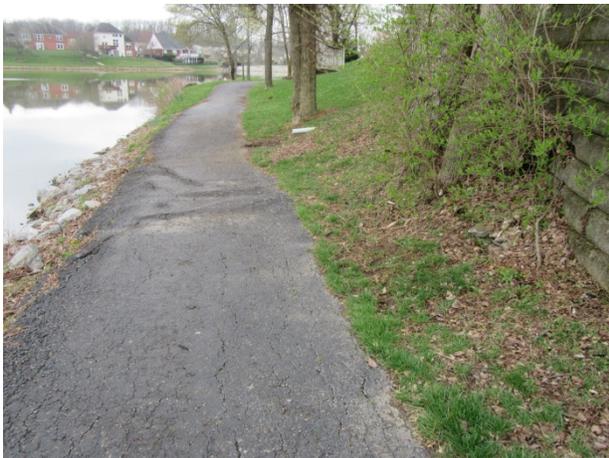
**Cracks and upheaval due to tree roots
northwest of central pond**

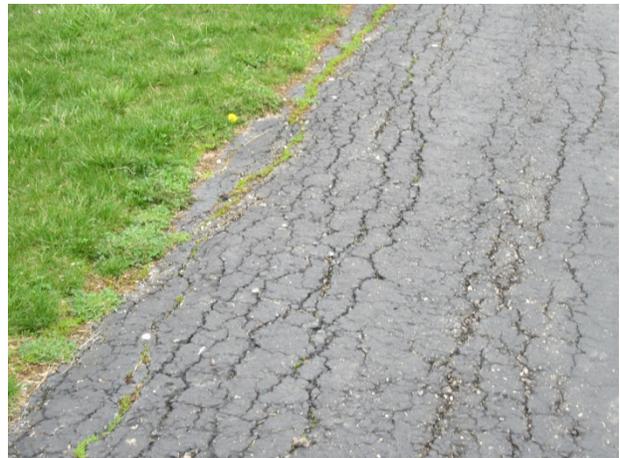
**Alligator cracks and organic growth west of
central pond**

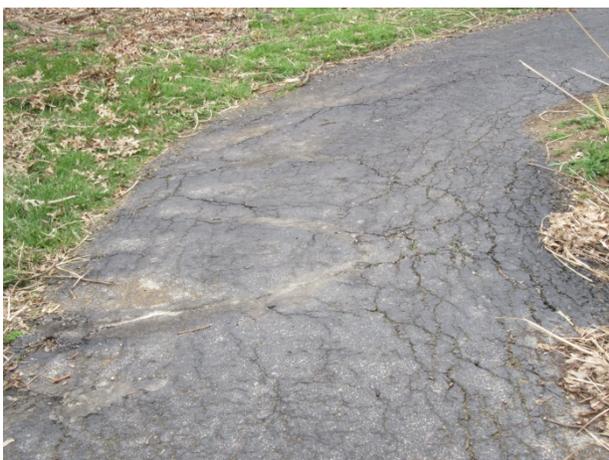
**Alligator cracks and uneven pavement north of
central pond**

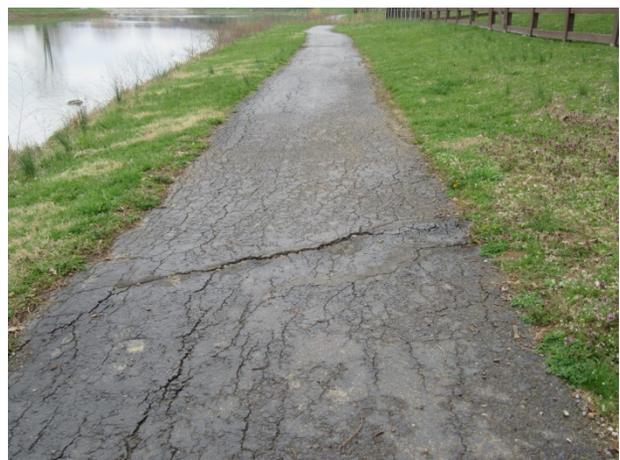
Cracks north of central pond

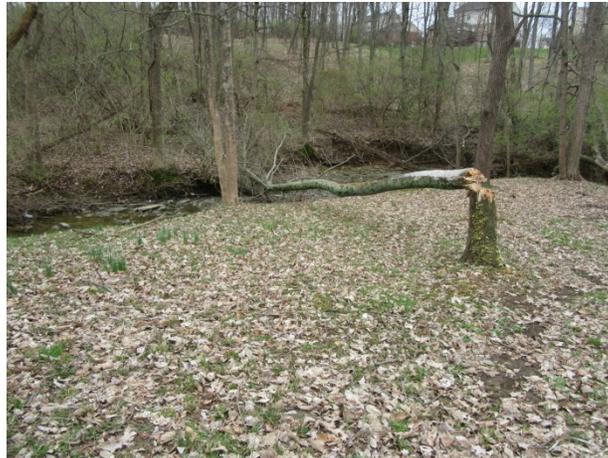
Fallen tree at rear of Foxhunt Drive

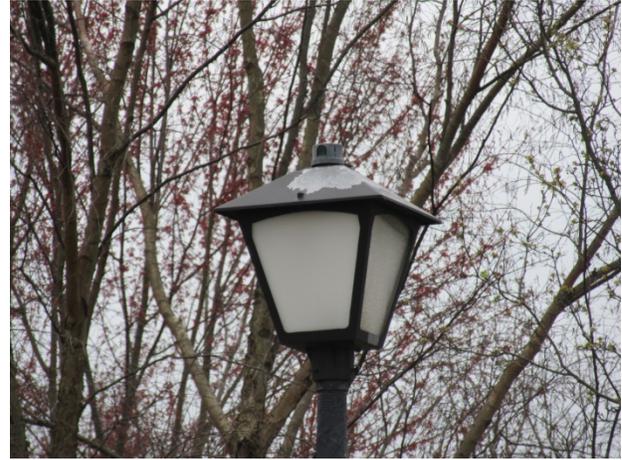
Finish deterioration at Chatsworth Court

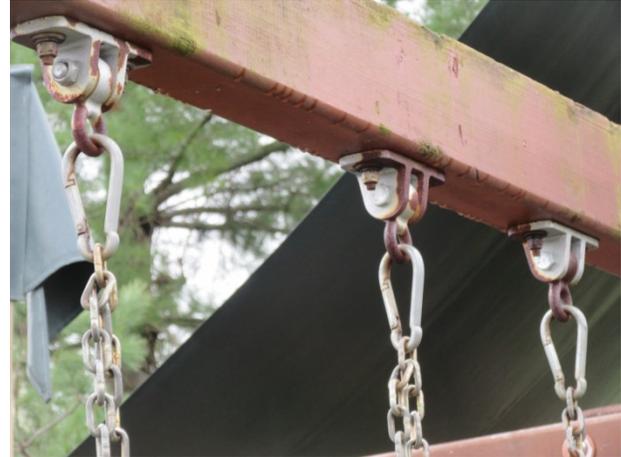
Rust and organic growth

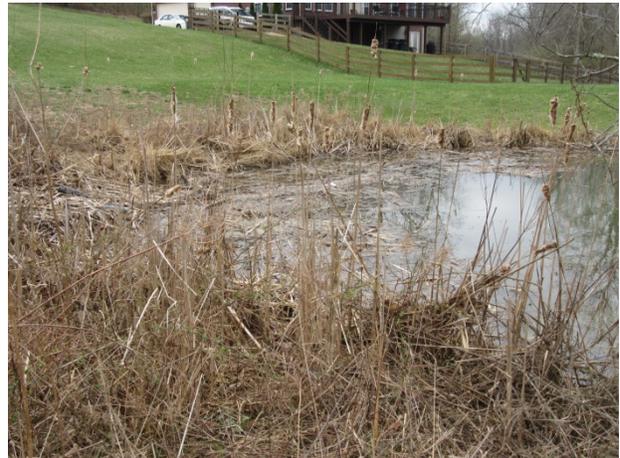
Cattails and organic accumulation at western pond

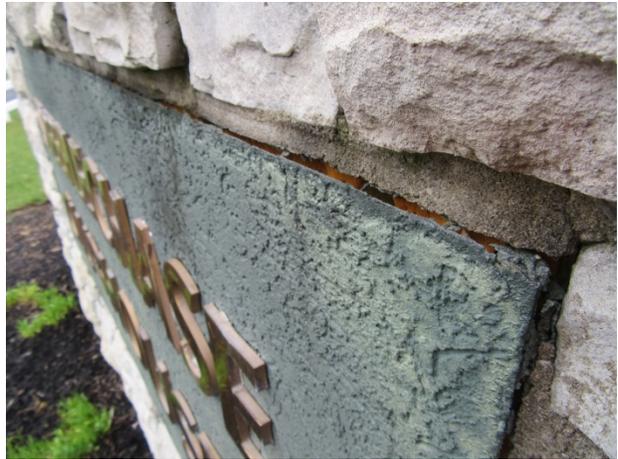
Separation and potential for water infiltration

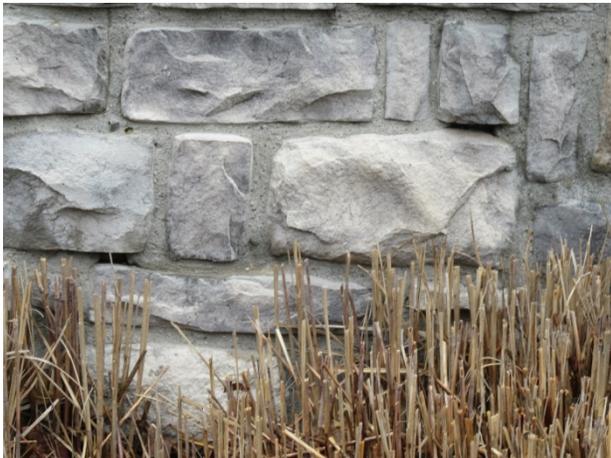
Clubhouse signage mortar deterioration

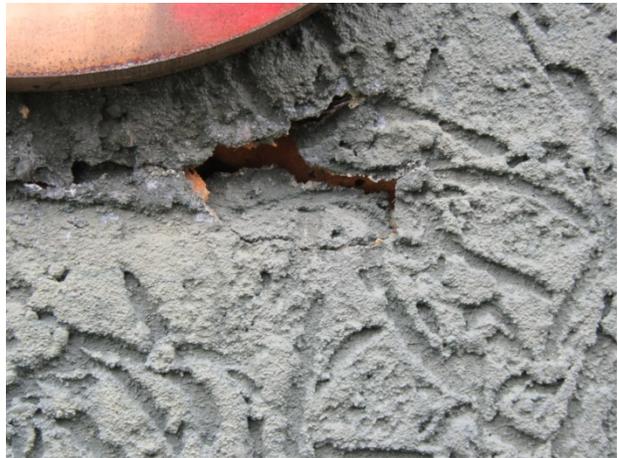
Clubhouse signage damage

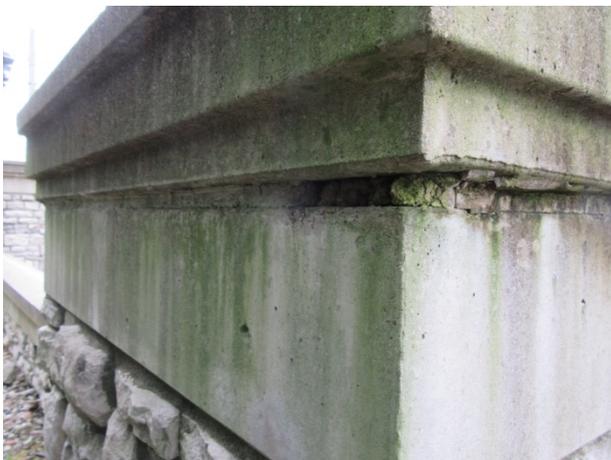
Entrance monument mortar deterioration

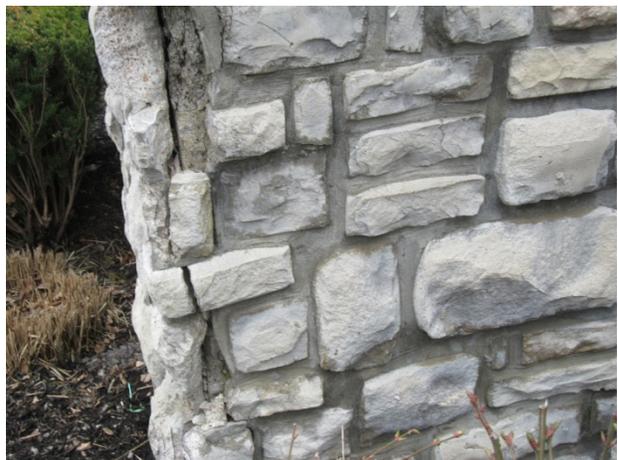
Cracks and deterioration at entrance monument

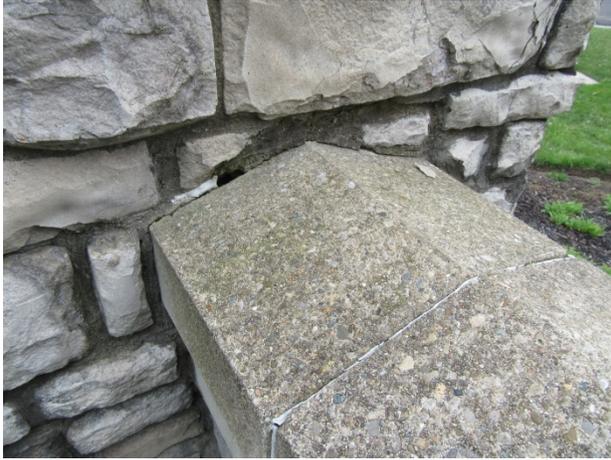
Deterioration and potential for water infiltration at entrance monument

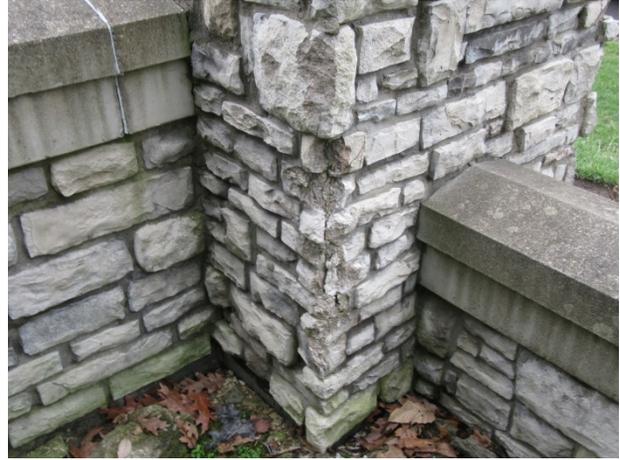
Cracks and deterioration at entrance monument

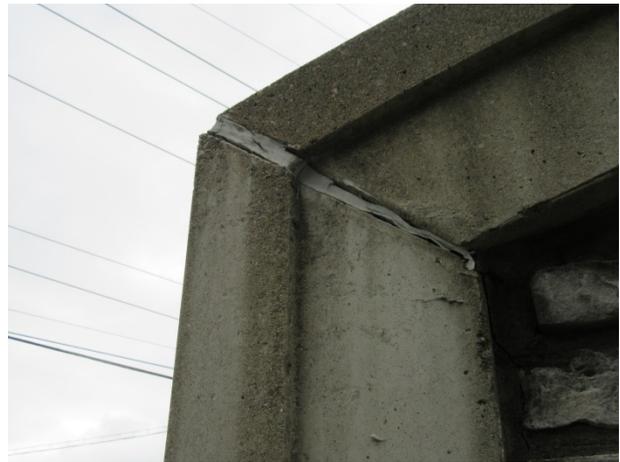
Adhesive and cohesive sealant failure at entrance monument

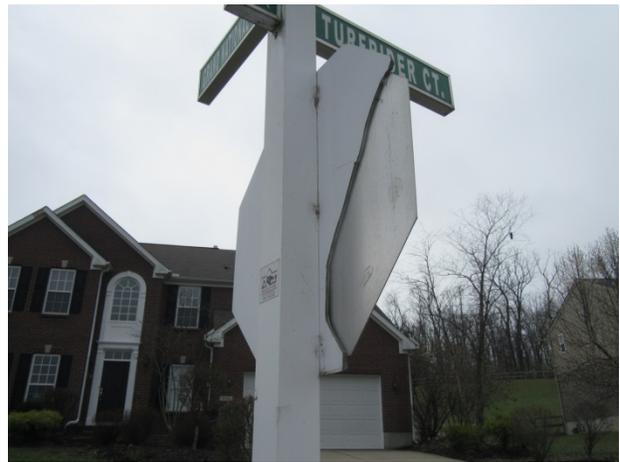
Damage at Turfrider Court

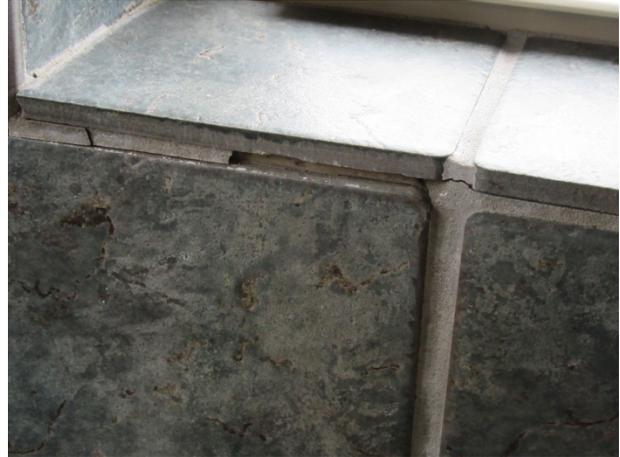
Grout deterioration

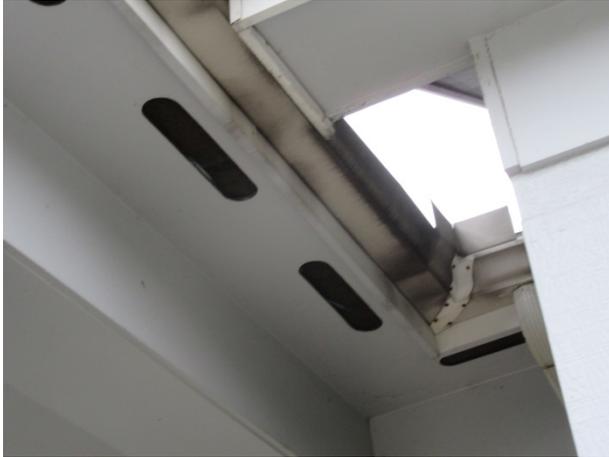
Discoloration at rear

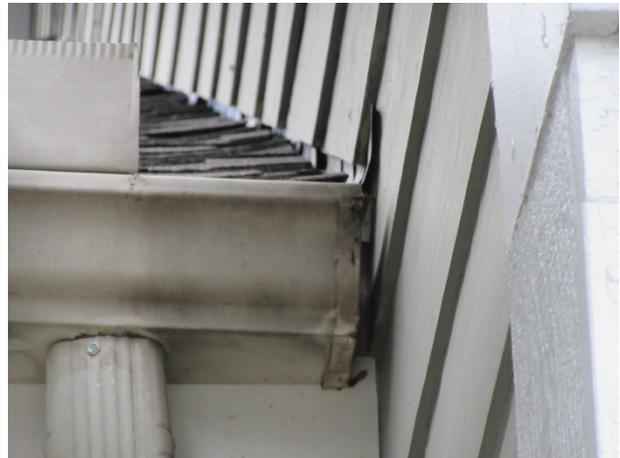
Displaced gutter (cause of overflow)

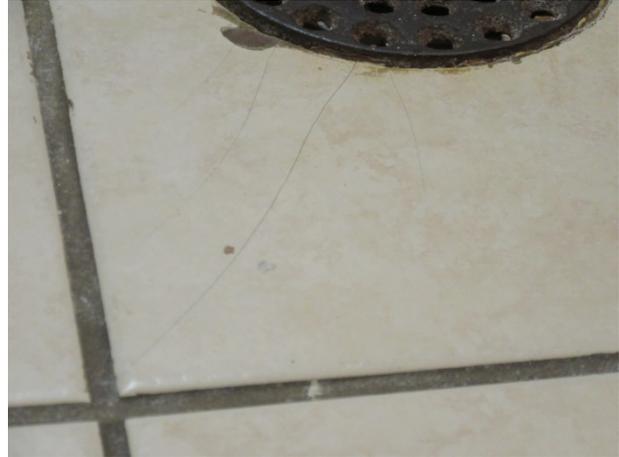
Cracked tile in rest room

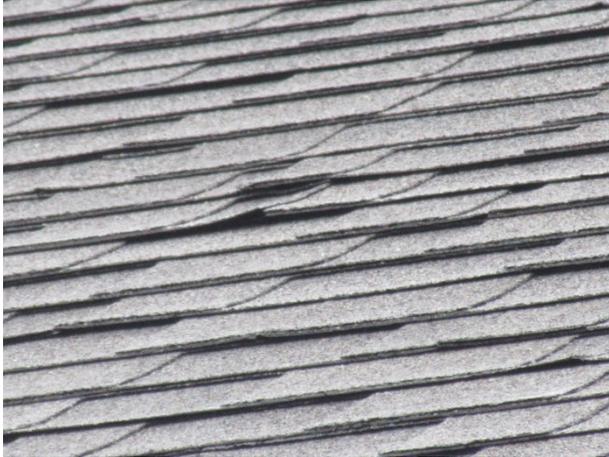
Condition: Good to fair overall with isolated shingle lift evident from our visual inspection from the ground. Management does not report a history of leaks.

Shingle lift at rear

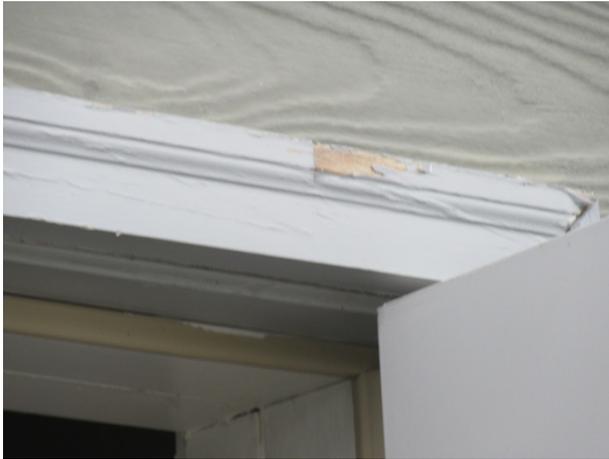
Paint deterioration above rear door

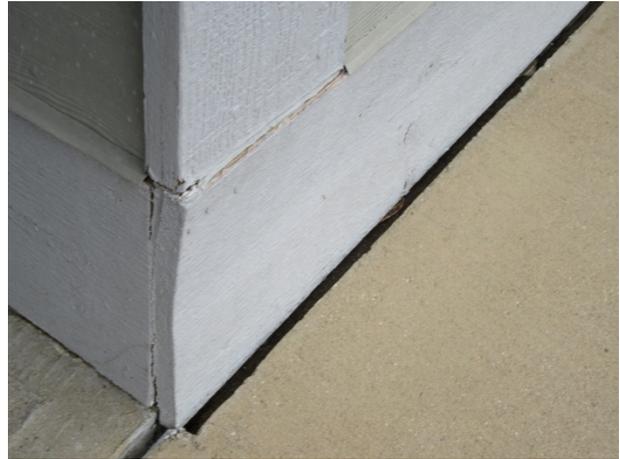
Bow at rear

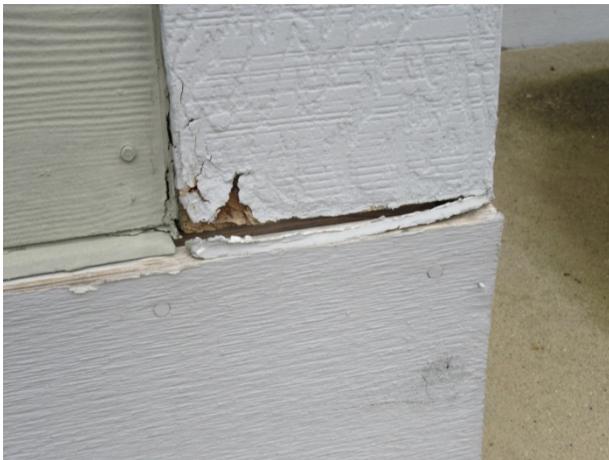
Wood rot at rear

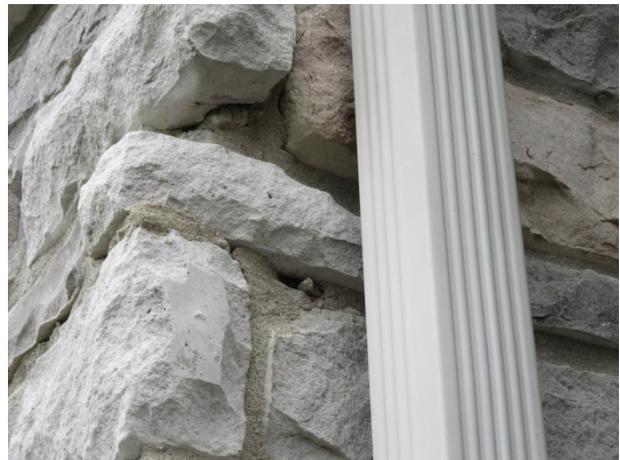
Mortar deterioration

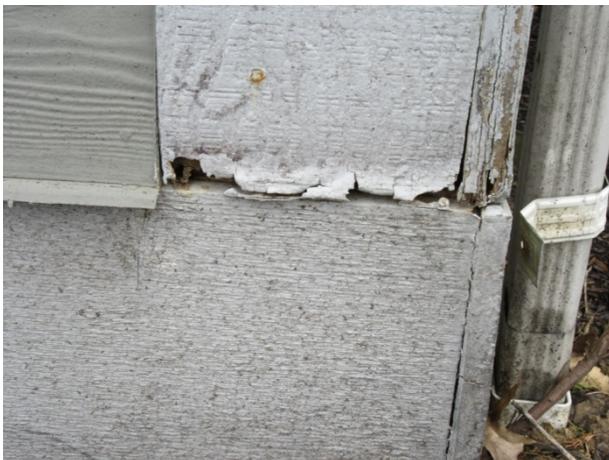
Wood rot at front

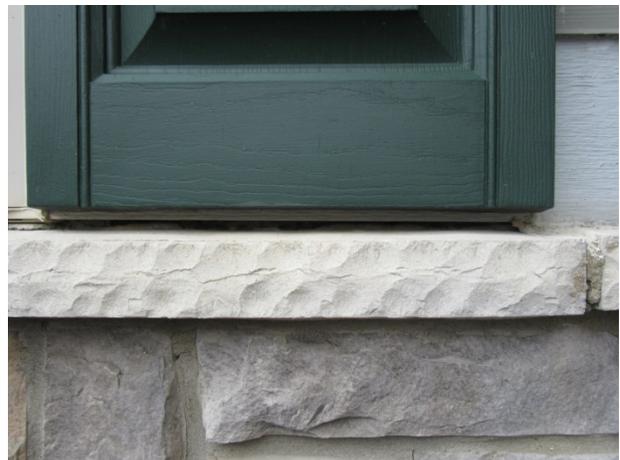
Missing sealant and potential for water accumulation

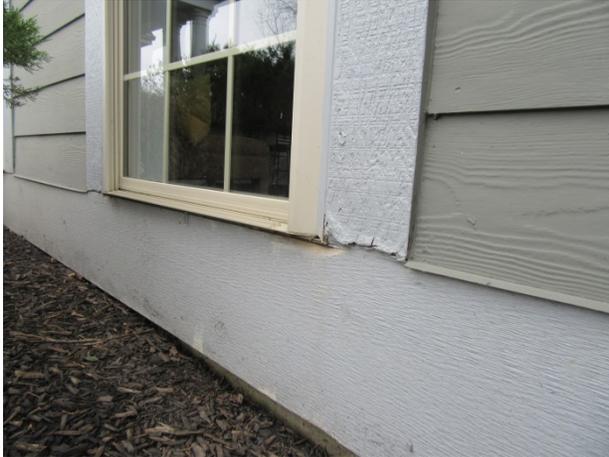
Wood rot at western side

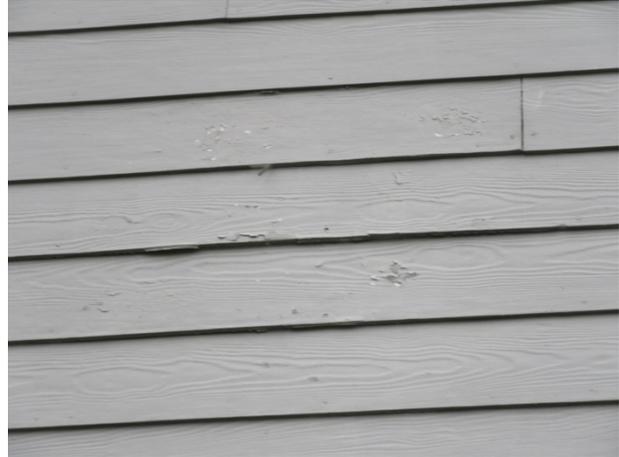
Paint deterioration at western side

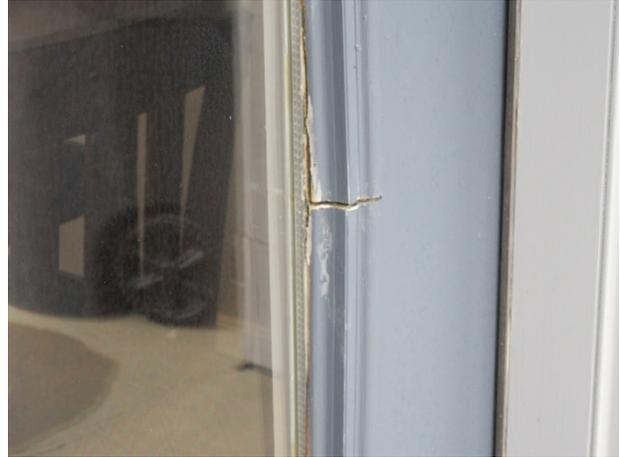
Rear door frame deterioration

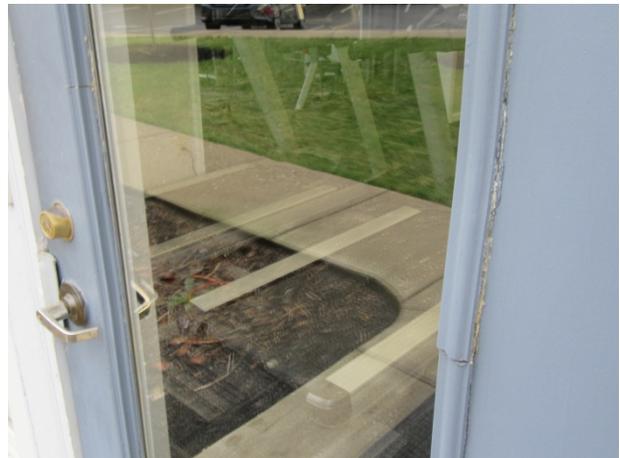
Gym door frame deterioration

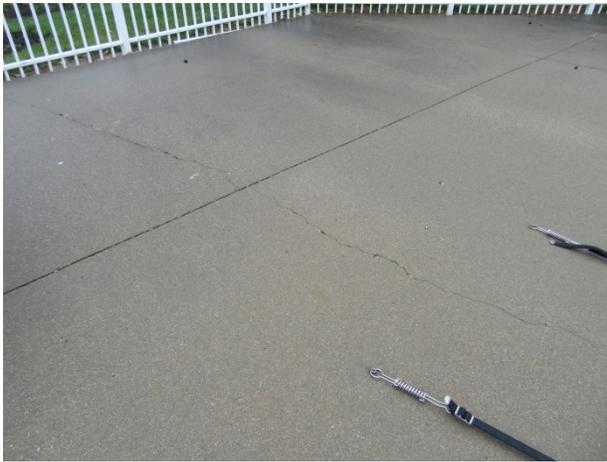
Pool deck crack

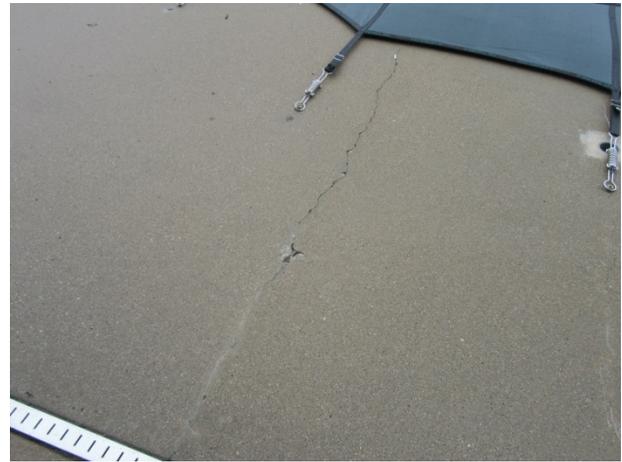
Pool deck crack

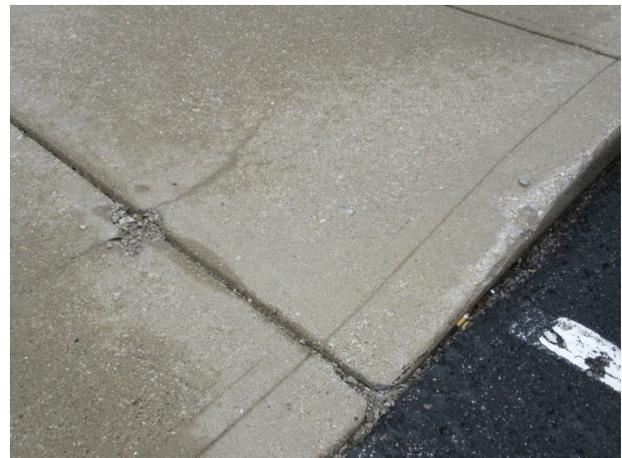
Sidewalk deterioration

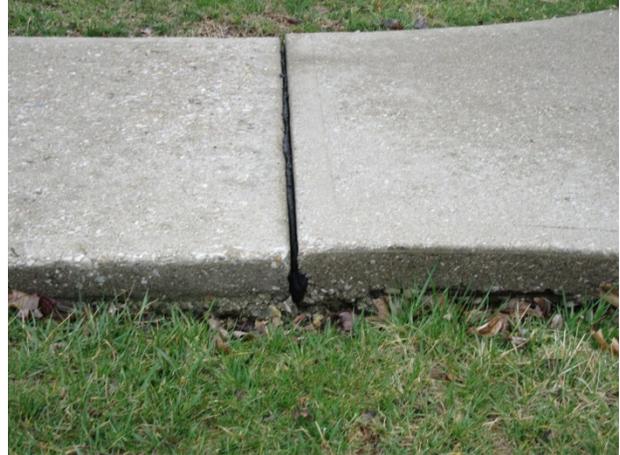
Sidewalk settlement

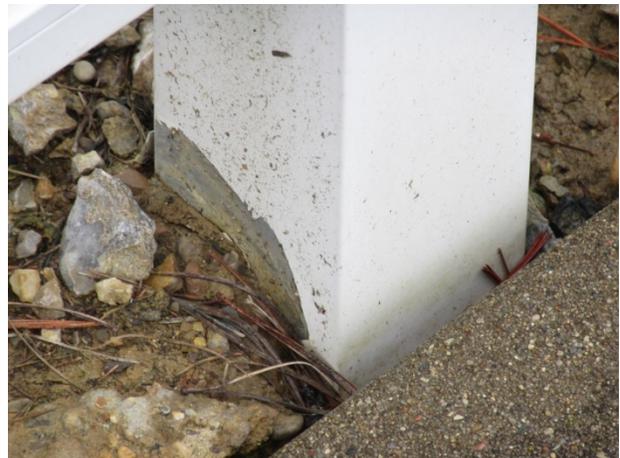
Finish deterioration
