FULL RESERVE STUDY

Steeplechase Subdivision

Homeowners Association, Inc.

April 5, 2019

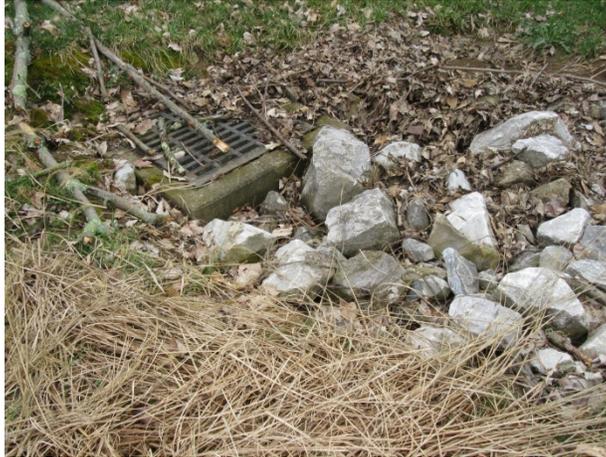
We note the potential for an increased rate of deterioration due to water flow directed to the side of the catch basin near Foxhunt Drive. We recommend the Association fill this area to be level with or above the catch basin and fund this activity through the operating budget.

Catch basin near southeastern end of Foxhunt Drive

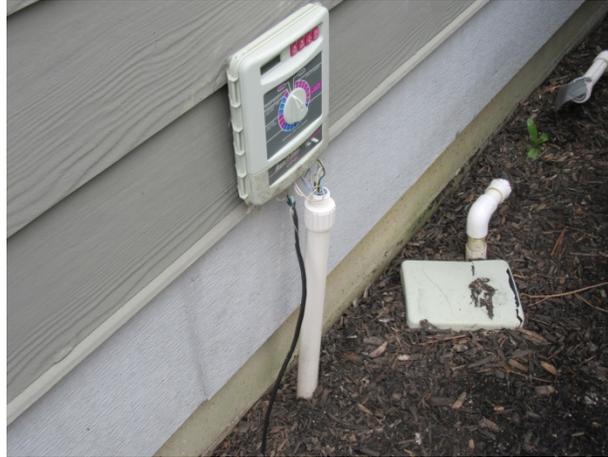
Exposed wiring and control panel

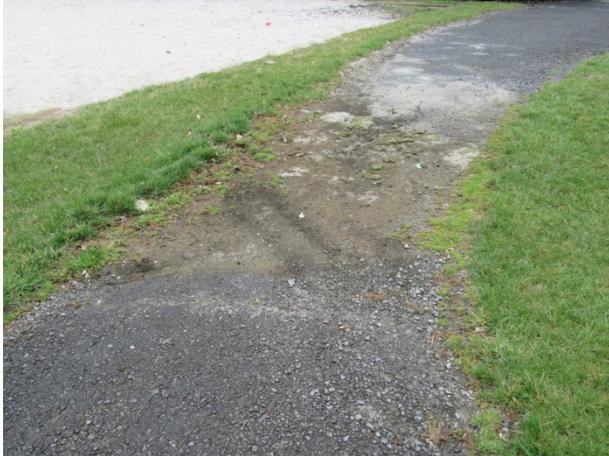
Condition: Fair to poor overall with isolated areas of uneven pavement, organic growth, and extensive cracks evident. We note some cracks are likely caused by tree roots and recommend these trees be removed as included in Line Item, “**Landscape, Ash Tree Removal/Replacement**”. Approximately five percent (5%) of the pavement is in poor condition and approximately six percent (6%) has been recently repaved.

Organic growth near clubhouse

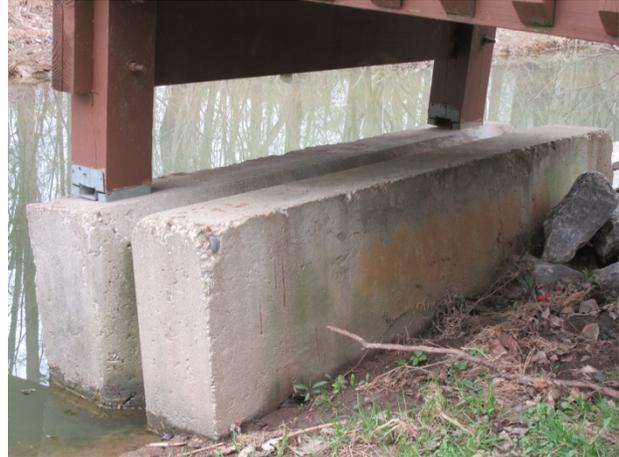
Condition: Fair overall condition. We note settlement of the concrete footing at the eastern bridge. We recommend remediation of this condition through the operating budget.

Settlement of concrete footing

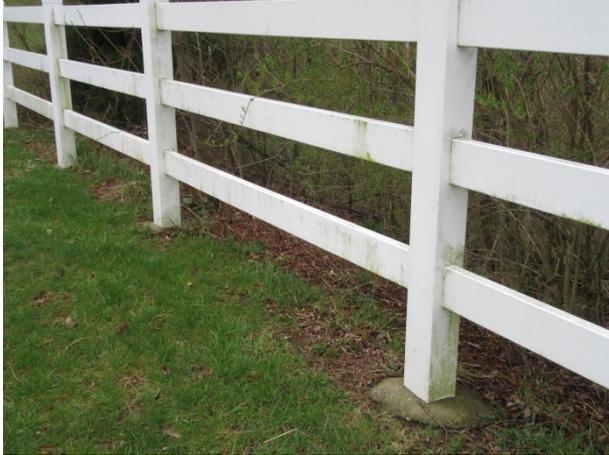
Condition: Good to fair overall with isolated organic growth evident

Organic growth

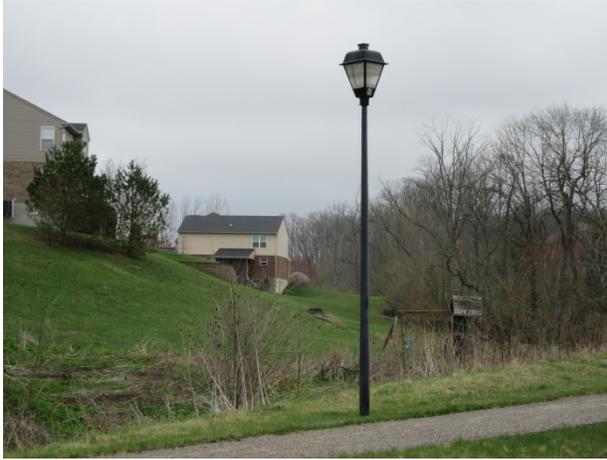
Condition: Good to fair overall with isolated finish deterioration evident

Light pole overview

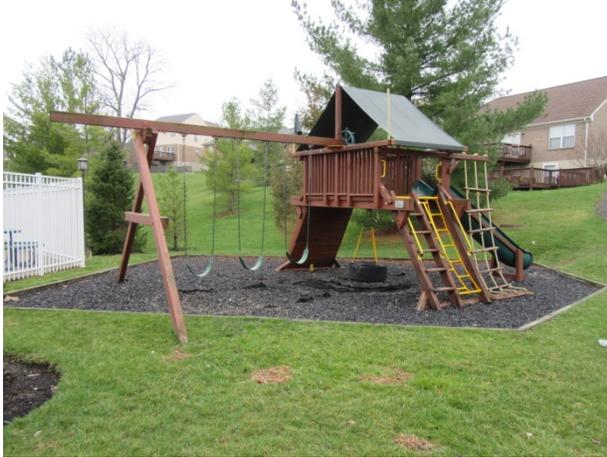
Condition: The current playground is in good to fair overall condition with isolated rust evident. We assume the playground to be installed in 2019 is in good condition with no significant deterioration evident.

Playground equipment overview

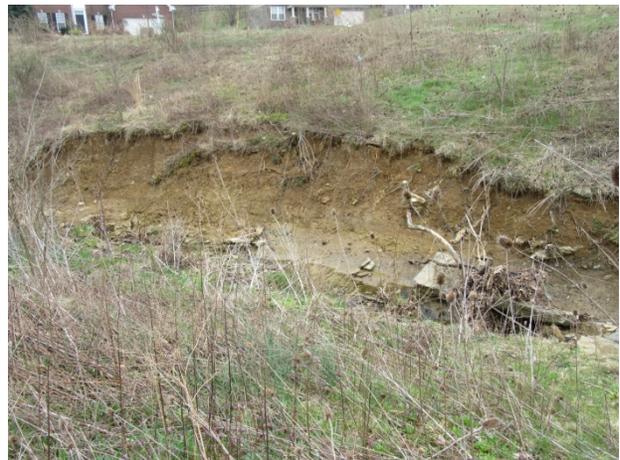
Condition: We note small areas of plantings along the main shorelines which act as buffer zones to control erosion. The southwestern shoreline of the central pond is lined with rip rap. We note extensive erosion at the inlet/outlet channels which will likely increase sediment accumulation.

Erosion near Turfrider Court

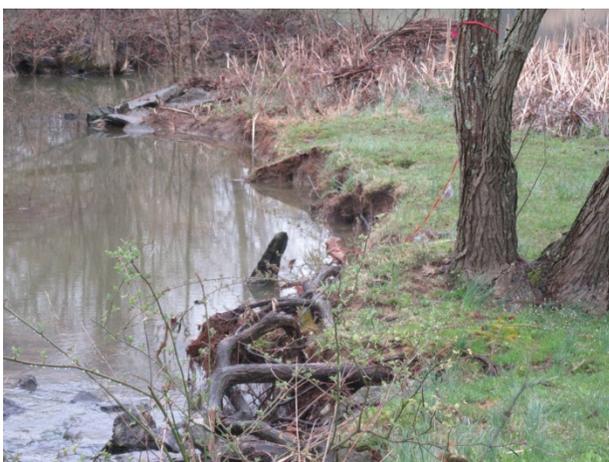
Western pond northeastern inlet channel erosion

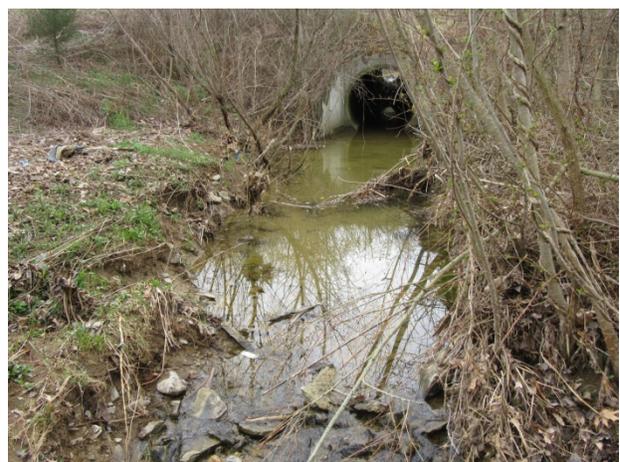
Organic accumulation and erosion near Turfrider Court

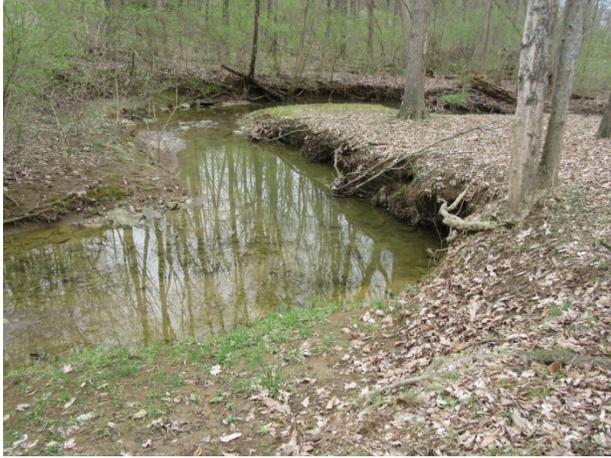
Erosion at central pond eastern inlet channel

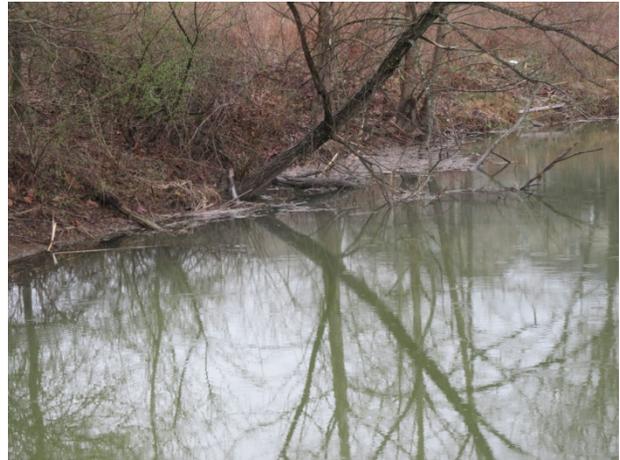
Fallen tree at western pond eastern shoreline

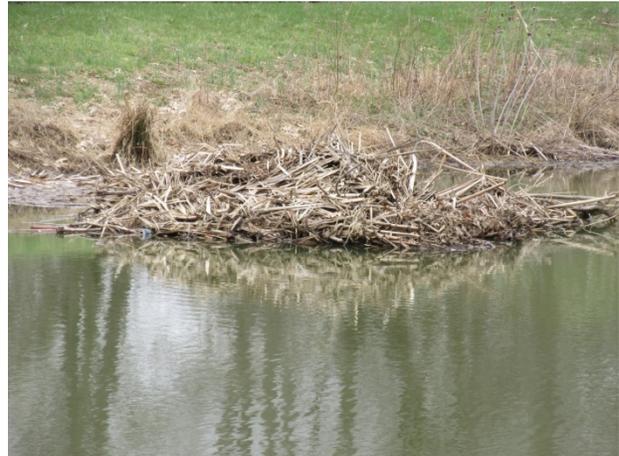
Condition: Good to fair overall with isolated debris accumulation evident.

Debris accumulation at western pond control structure

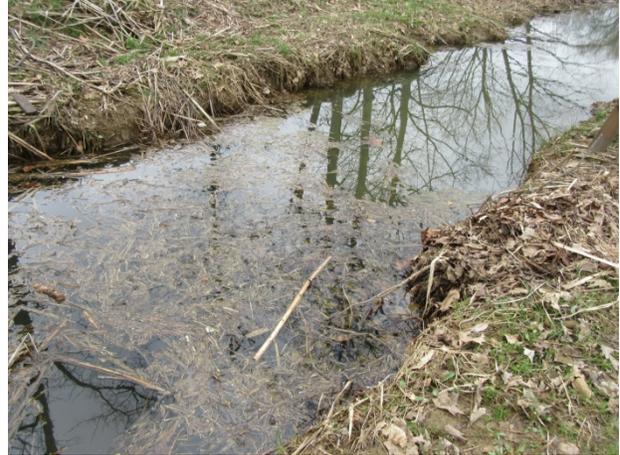
- **Central Pond:** 30,530 square yards with isolated organic accumulation visually apparent
- **Inlet/Outlet Channels:** 2,500 linear feet with systematic organic accumulation visually apparent. The unprotected shorelines of the channels will likely increase the rate of sediment accumulation.
- **Western Pond:** 6,550 square yards with isolated organic accumulation. We note areas of cattails that have accumulated in the pond. We recommend the Association conduct regular maintenance of the area to remove this organic material each season.

Organic accumulation at western pond southeastern inlet channel

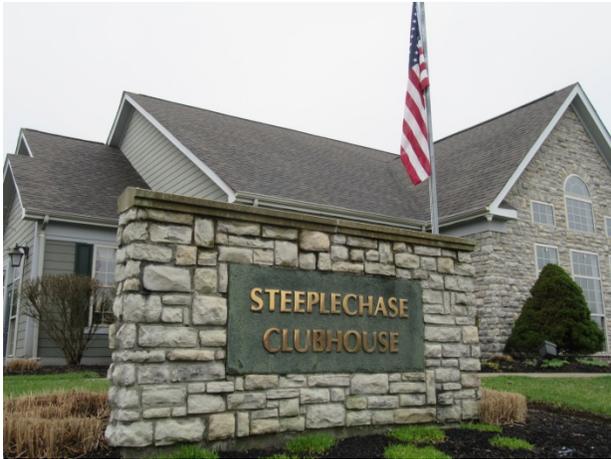
- **Clubhouse:** One original monument in fair overall condition with isolated deterioration and damage evident.
- **Entrance Monuments:** Two original monuments in poor condition with systematic cracks, deterioration and sealant failure evident.
- **Street:** 19 posts with street identification and stop signs which date to 2013. Management informs us the Association cannot find a suitable replacement for the solar-powered lights. We note isolated damage.

Clubhouse signage overview

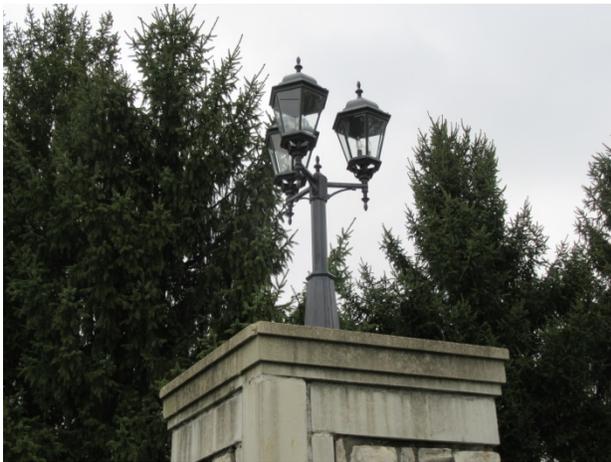
Light fixture overview

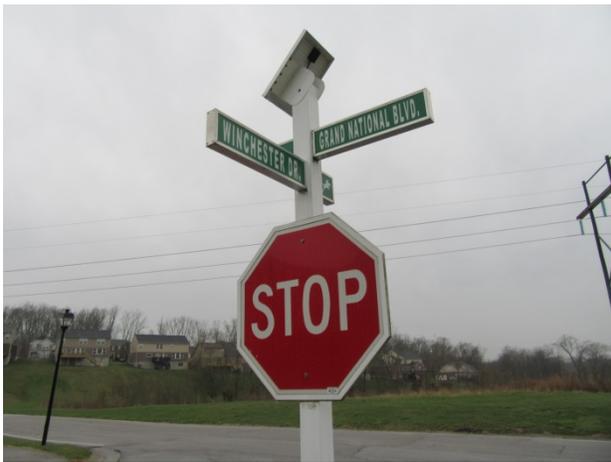
Street sign overview

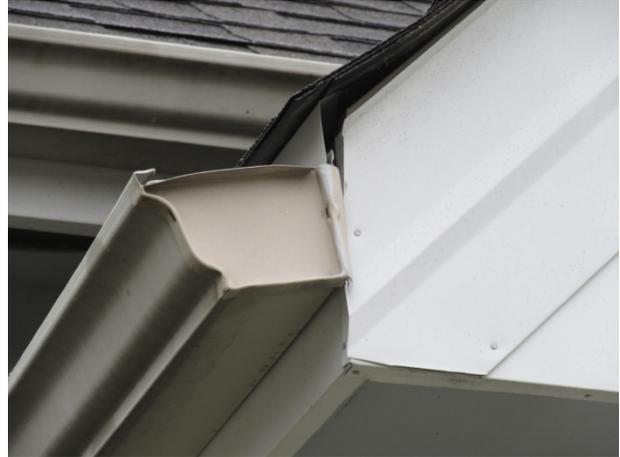
Condition: Fair overall with isolated discoloration and displacement evident. We note evidence of overflow at the rear of the clubhouse.

Lifted apron at rear

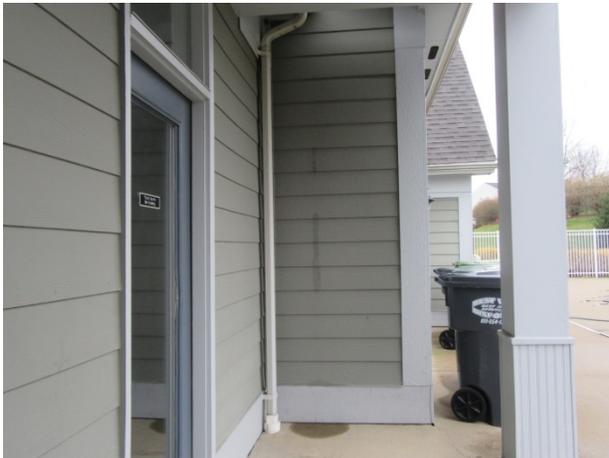
Overflow at rear

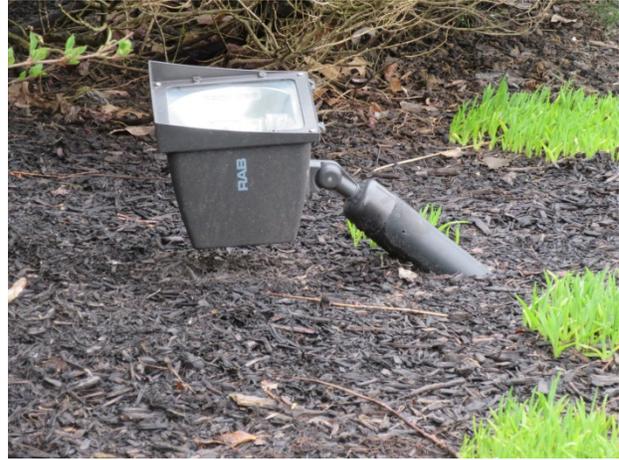
Condition: Fair overall with isolated finish deterioration and displacement evident

Displaced light fixture

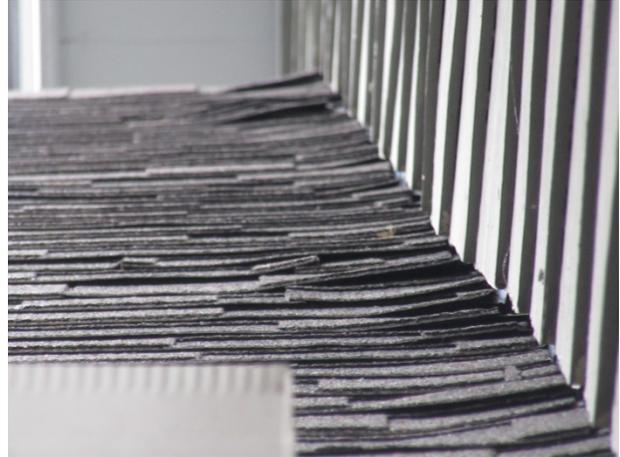
Condition: Good to fair overall with isolated shingle lift evident from our visual inspection from the ground. Management does not report a history of leaks.

Shingle lift at rear

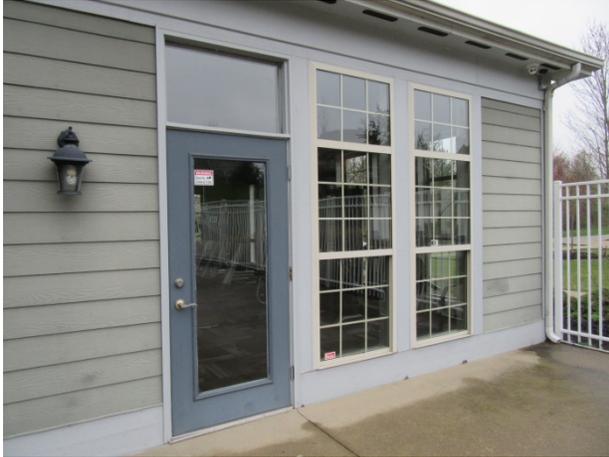
Condition: The majority of the windows and doors are in good to fair condition. We note frame deterioration at the four windows and doors located at the side of the gym and the rear of the main room.

Window and door overview

Quantity: Approximately 785 square feet total. We recommend the Association conduct near term replacement of approximately 85 square feet due to deterioration of the wood frame. In addition, we recommend the Association anticipate the need to replace 125 square feet of the remaining doors prior to the remaining 575 square feet of windows.

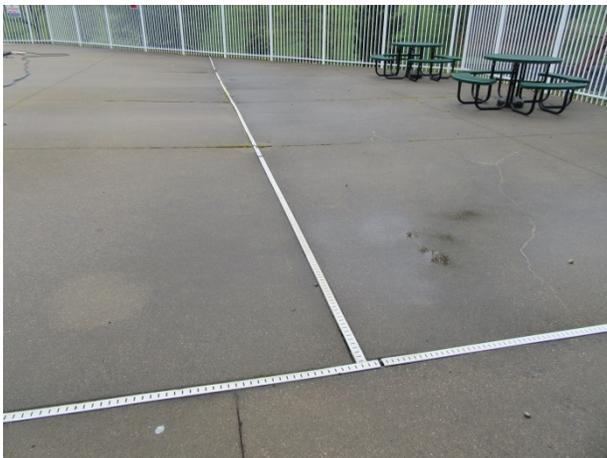
Condition: Fair condition overall with isolated cracks, deterioration and settlement evident

Crack repairs and organic growth

- Selective cut out and replacements of up to ten percent (10%) of concrete
- Crack repairs as needed
- Mortar joint repairs
- Caulk replacement

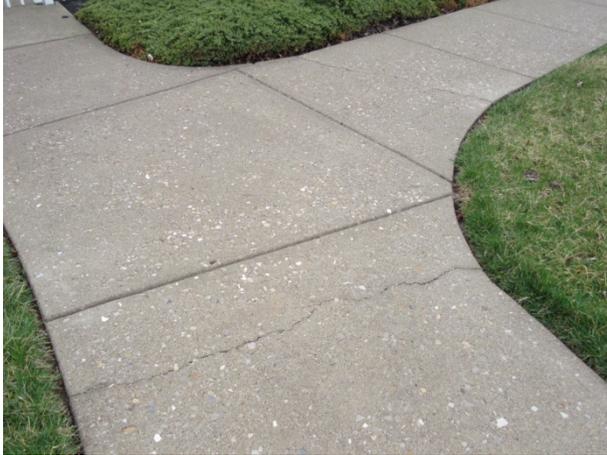
Sidewalk cracks

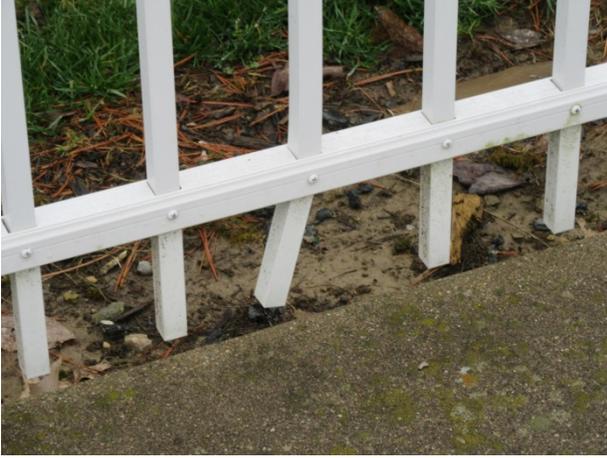
Condition: Fair overall condition with isolated finish deterioration, bent pickets and lean evident

Bent picket

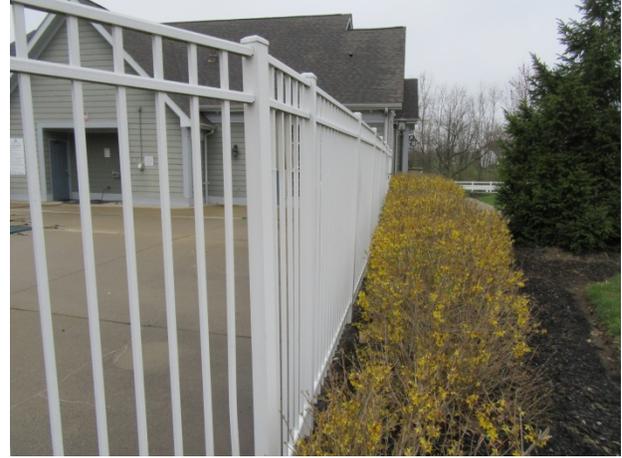
Slight lean
